# Severe Service Journal

Volume 9 Issue 2, April 2009

## MIDWESTERN POWER PLANT USES CAV4 TRIM TO AVOID RECIRCULATION VALVE LEAKAGE PROBLEMS

## DESIGN EHAZ VALVES WITH CARBIDE LINERS DELIVER RELIABILITY

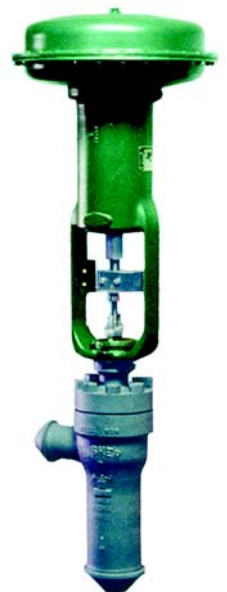
The CAV4 trim was designed specifically for feedpump recirculation applications. This solution incorporates four stages of anti-cavitation protection, a technique that prevents the formation of damaging cavitation at pressure drops up to 6000 psid.

A properly sized CAV4 valve prevents cavitation, and therefore the noise and vibration it causes, by directing flow through successively larger flow areas, with each causing a reduction in pressure. This "staging" of the overall pressure drop results in more than 90 percent of the total drop being taken in the first three stages where there is little danger of bubble formation. The last stage experiences a low inlet pressure and pressure drop.

The pressure staging together with the separation of shutoff and throttling locations within the CAV4 trim prevent seat erosion. The trim design does not allow significant pressure drop to be taken until the fluid is downstream of the seating surface. All clearance flow is subjected to a staged pressure drop.
