Severe Service Journal

Volume 3 Issue 2

June 2003

REPLACEMENT TURBINE BYPASS VALVE ADDRESSES CRITICAL TRIP CONDITIONS

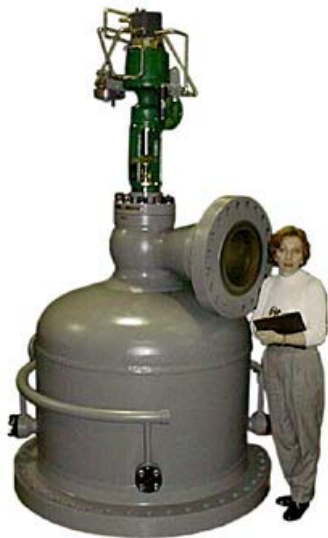
Turbine bypass applications are the most critical valves in a combined cycle power plant. Given the large flows and high pressure drop, noise generation is also a concern. The CVX design (Figure 1) stages the pressure drop across a series of internal diffusers that lower the turbulence in the outlet of the valve body thus lowering the valve noise. The forged body design also readily fits nearly any piping system.

Figure 1: CVX Turbine Bypass Valve

An 800 MW combined cycle power plant in the UK had experienced repeated issues with their high pressure turbine bypass valves in full-load trip conditions. If the plant tripped under full load, the valves would not operate properly and would cause the gas turbines to trip off-line as well. In this configuration, the high pressure steam (130 bar) dumps directly to an air cooled condenser and is used during startup to warm the condenser and maintain condenser vacuum and to bypass steam flow to the condenser in the event of a steam turbine trip. The existing valves were replaced with two Fisher CVX steam conditioning valves with 132mm ports and 1066mm outlets.

After installation, the valves performed flawlessly during the startup of the boiler. Before installation, the typical cold start-up procedure would take up to 14 hours. After installation of the CVX valves, the start-up time was reduced to two hours.

In order to test the ability of the valves to control under a full load turbine trip, a simulated trip was planned. However, the plant had an unplanned trip two days after installation. The bypass valves performed exactly as anticipated and one of the gas turbine/boiler trains was able to continue its operation due to the fast and accurate control of the valves. The plant manager confirmed that had the previous valves been in place, the entire plant would have tripped.

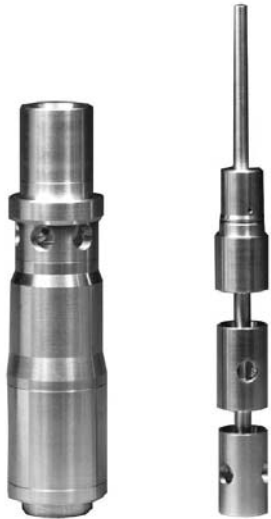
The DST design uses combined axial and radial flow paths that feature large openings that allow particulate up to 3/4" in diameter to pass while also eliminating the potential for velocity induced erosion.

The DST (Figure 2) also incorporates a protected seat design that separates the shutoff and throttling locations. All significant pressure drop is taken downstream of the seating surface. As a result, the seating surfaces are not worn away by throttling control action.

Figure 2: Dirty Service Trim

In order to address this issue, the plant turned to Fisher. A solution was developed that incorporated large passages that allowed the entrained particulate to pass while also providing pressure staging to eliminate the formation of damaging cavitation. The Dirty Service Trim, commonly referred to as DST, has been used repeatedly in applications where plugging and subsequent capacity restriction are concerns.

Since trim installation in 1996, the valve has yet to be opened. There have been no issues with a reduction in capacity or with leakage through the valves.
