# Severe Service Journal

Volume 4 Issue 4 | January 2006

## **DIRTY SERVICE TRIM MINIMIZES THE INFLUENCE OF OUTGASSING AND EROSION IN A REFINERY'S HYDROPROCESSING AREA**

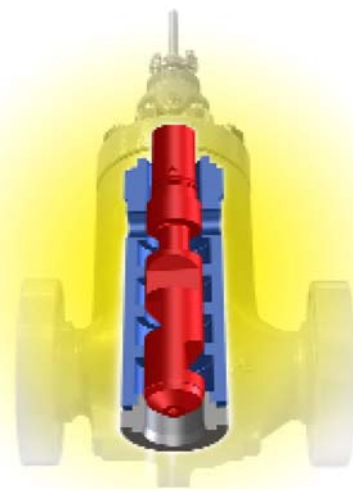
All of the DST solutions incorporate a protected seating design that separates the shutoff and throttling functions of the valve. This design ensures that no pressure drop is taken across the seating surface, protecting the valve from high velocity impingement and erosion while improving shutoff.

Fisher designed its DST products to address all of these application challenges. DST utilizes a staged pressure reduction and a large outlet chamber to reduce the velocities of the fluid coming out of solution. The large outlet chamber prevents high velocity jets from impinging on the valve body and contributing to erosion and vibration. The four-inch DST-G solution specifically was utilized to combat outgassing effects. Its optimized design allowed the facility to utilize a smaller valve than the one previously used.

DST and NotchFlo<sup>®</sup> DST solutions, ranging from 1- to 4-inches, were utilized in the Cold High Pressure Separator system. Each of these designs combat damaging cavitation and flashing while allowing particulate up to 1/2-inch in diameter to pass without plugging the trim.
